A1 SEACAP 21

Slope stabilisation trials on Route 13N and Route 7 in Lao PDR

The Project in Detail

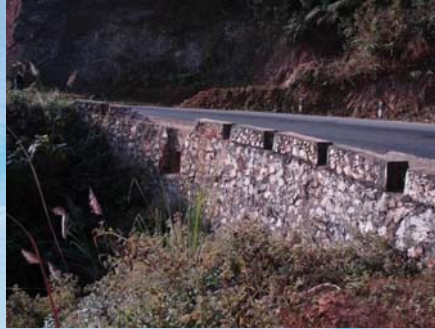
C22

Typical Mortared-Masonry Wall

- Likely to be used above and below the road.
- Most commonly constructed of Mortared-Masonry in Laos and SE Asia (gravity walls).
- Gabions and 'composite' walls can also be used

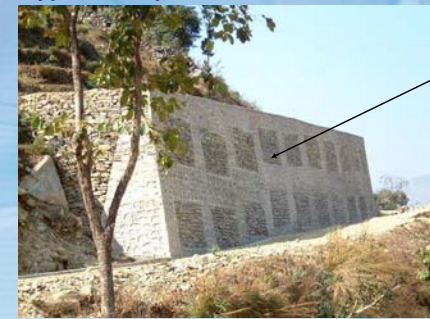
C23

Typical Composite Wall

Dry Stone
